The Examination of The Main Transportation Arteries of Konya In Terms of Landscape Architecture Design Criteria

Sertaç Güngör* Ahmet Tuğrul Polat

Department of Landscape Architecture, Faculty of Agriculture, University of Selçuk, 42075 Konya, Turkey

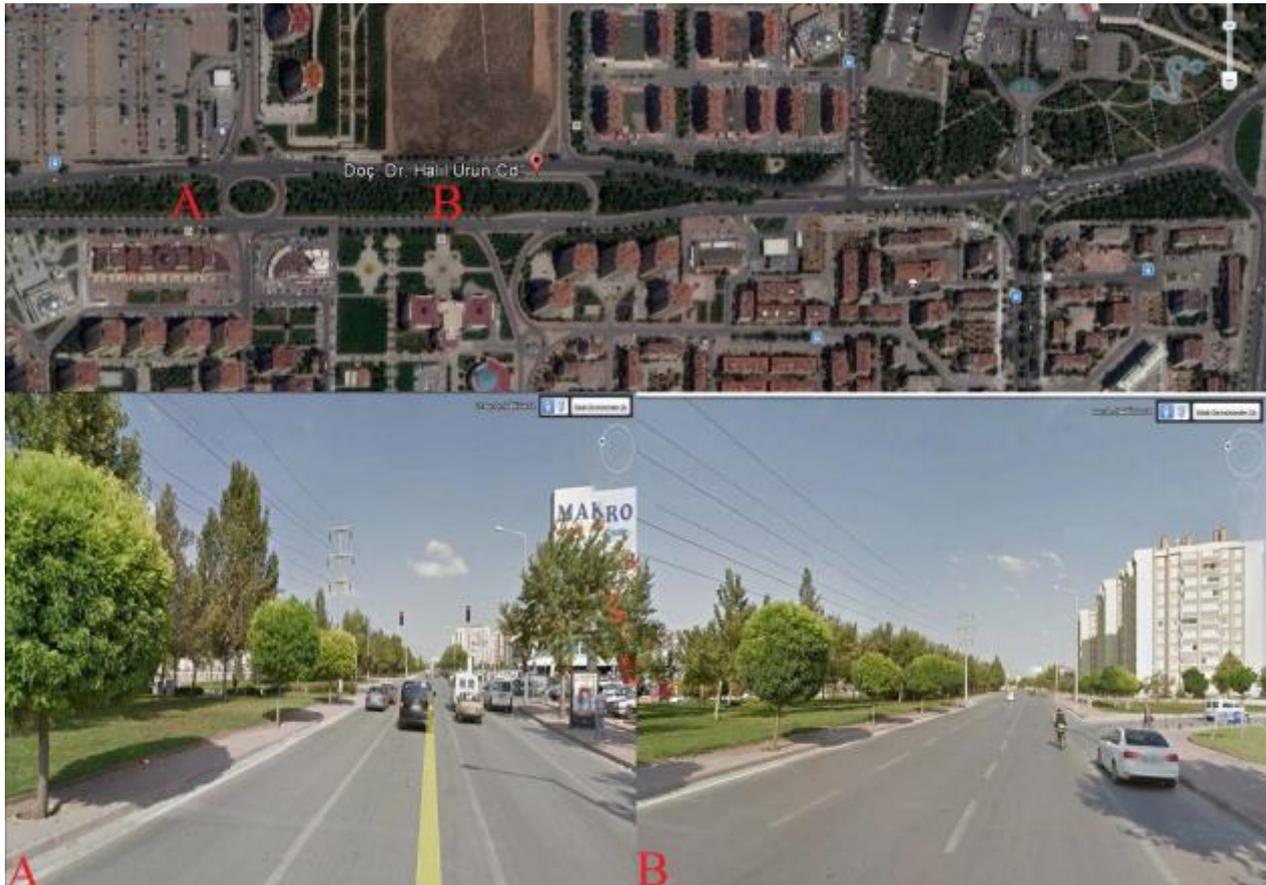
The length of the street, which begins from the bus terminal and reaches the bus terminal bridge crossing (the end of Barış Street), is approximately 1.7 km. The width of the street, except for the central refuge, is approximately 24 m. The material type of the street is asphalt. This street has a very wide refuge. The refuge width is 45 m at the widest section and 5m at the narrowest section. The pavement width is approximately 3m. Figure 1 shows the satellite image of the street and pictures taken from the marked places A and B.

Figure 1 Google view of Halil Ürün street.

Thick-textured and bottom branching species should be used in the central refuge to diminish a headlight effect due to the busy usage of the street at night. However, there are not enough low bushes which will ensure that the driver will not be disturbed by the headlight in the central refuge.

Medium-density evergreen plants are used on the street. The use of coniferous plants is a wrong preference on such a heavily used street with the opening of the new stadium because especially evergreen species are negatively affected by the exhaust gases from vehicles. Deciduous species such as *Acer campestre*, *Acer platanoides*, and *Aesculus hippocastanum* are also affected negatively by the exhaust gases.

Two people cannot walk side by side in the pavement section of the central refuge allocated for pedestrians. Pavements were not designed of sufficient width in terms of anthropometrical standards .

Besides, *Acacia ssp.* is located on the walkway. These trees render pedestrian access difficult due to the fact that the height of their crown sections from the ground is shorter than 172 cm (beginning of the branching of an ideal pedestrian walk tree).

The plants were planted in the central refuge along a straight line in order to be watered easily with drip irrigation. This weakens the visual effect of the plants aesthetically.

The pedestrians crossing the street damage the grass in the central refuge because of the insufficient pedestrian roads in the central refuge. Stepping stones or interlocking paving stones need to be paved on the passes which pedestrians heavily use. As a result of the observations carried out on the street, it was observed that especially Plane Tree grew inclined due to faulty planting and phototropism (tendency to light). The species with malformation need to be staked and straightened.

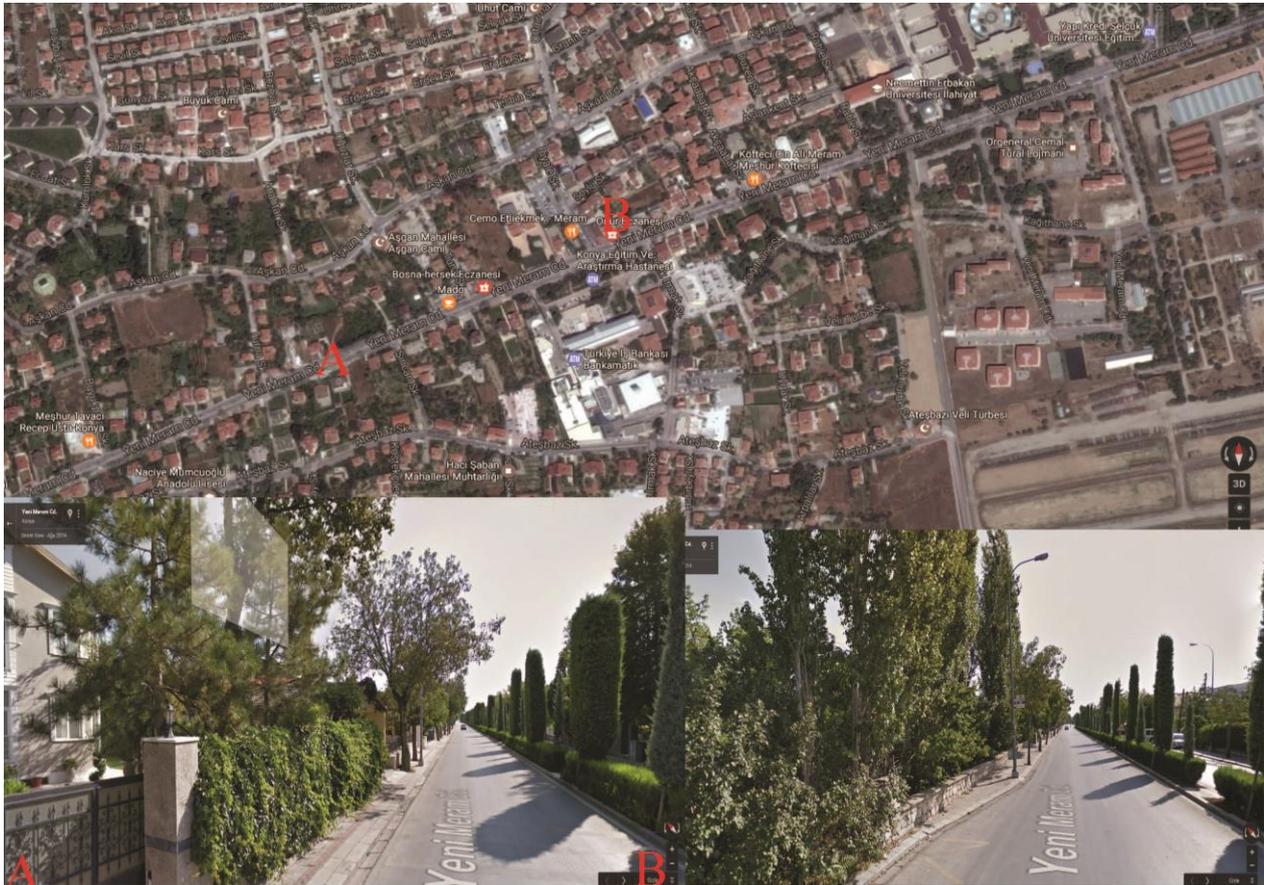
This street was replanned by Konya Metropolitan Municipality Parks and Gardens Department and with the help of Konya Metropolitan Municipality Directorate of Technical Works as of 2008. It became the most prestigious street in Konya. The pavements, curbs, and refuges on the street were completely paved with andesite. The road was widened and passages were rendered more secure at the junction of Yeni Meram Street. Figure 2 shows the satellite image of the street and pictures taken from the marked places A and B.

Figure 2 Google view of Yeni Meram street

The problems observed on the street are as follows: the trees in the vicinity of the SSK Hospital create unnecessary crowns and prevent vehicles from passing. Besides, the parking problem exists in the section of the hospital which overlooks the street. This problem repeats due to some trees' having a wide crown structure on pedestrian walks, as well.

Cupressus sempervirens was used in the central refuge for the purpose of emphasizing. Since the width of the refuge is narrow, the selection of this species is correct.

However, the cypress species is very high in accordance with the anthropometric measurements. This endangers the safety of power lines.

People drop litter aside the trees and drop cigarette stubs under the trees because of the lack of trash bins on pedestrian roads or insensibleness of people.

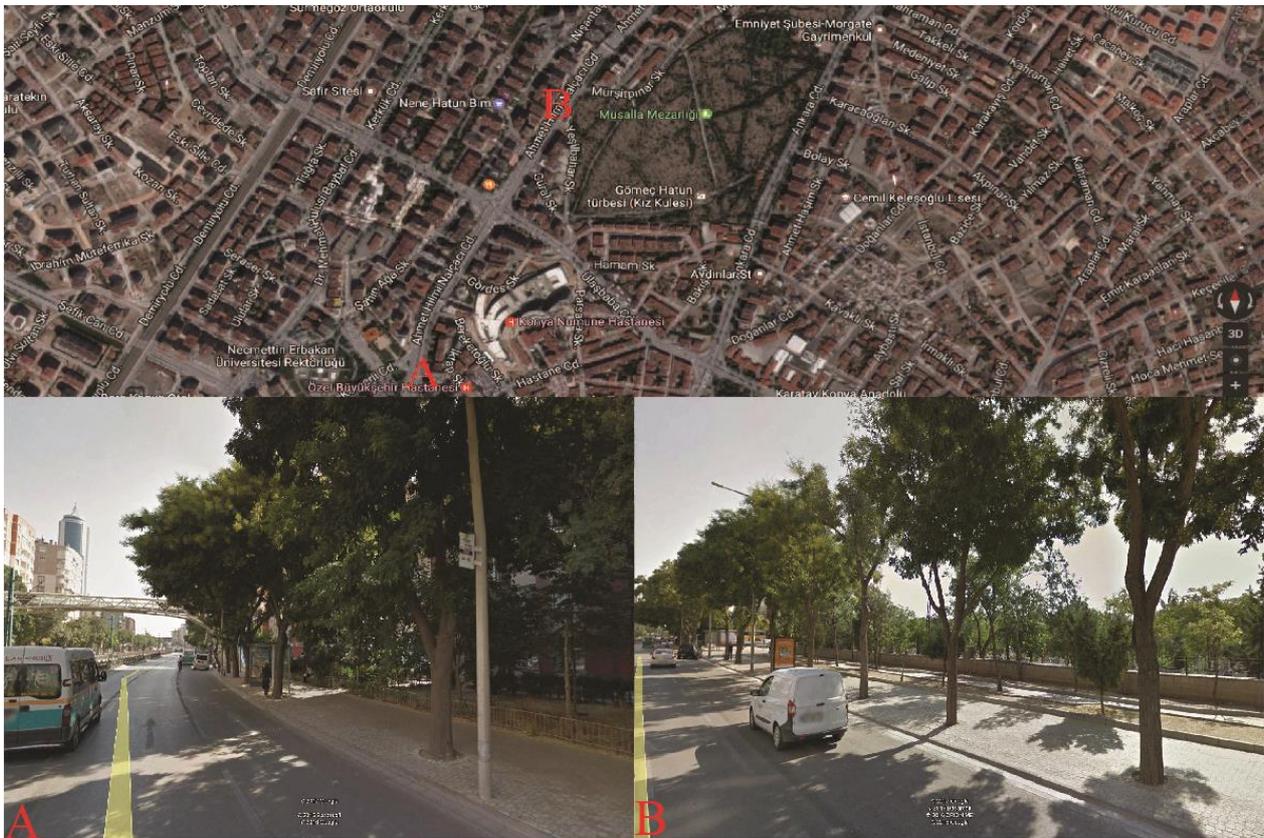
The length of the street from Konya Metropolitan Municipality to Kunduracılar location is approximately 2 km. The width of the street, including the central refuge, is 39 m. The material type of the street is asphalt. The refuge width is approximately 10 m. The width of the pavement is approximately 4 m. Figure 3 shows the satellite image of the street and pictures taken from the marked places A and B.

Figure 3 Google view of Nalçacı street

Fraxinus excelsior was planted too often in such a way that their crowns would interpenetrate. The trouble here is that the crown width of the tree in the following years was not taken into consideration. Hence, on this street, species

were selected without knowing the characteristics of the plants and without the dendrologic information required in terms of landscape architecture. In order to overcome such problems, complication can be eliminated by pruning aesthetically and in a way that will not damage the plant.

Thus, while carrying out adjustments on the roads, the factors such as species' ecological desire, height, crown width, suitability to the area should be taken into consideration and most importantly, a feasibility and analysis study regarding the area should be carried out and a design should be created.

A parking lot with a sufficient capacity was not designed for the banks located in the pedestrian section of the street. Pedestrian accesses are not possible as a consequence of the vehicles' parking on the pavement. Pedestrians who cannot walk on the pavement have to get down on the roadway and get into danger.
